CASE REPORT

Detection of incorrect manufacturer labelling of hip components

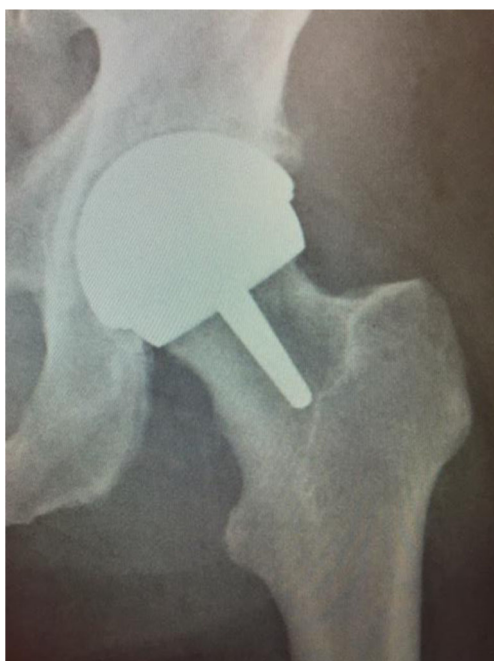
Fig. 1 Post-operative anterior-posterior plain film radiograph of the patient's left hip. No cause of the patient's mechanical symptoms was detected

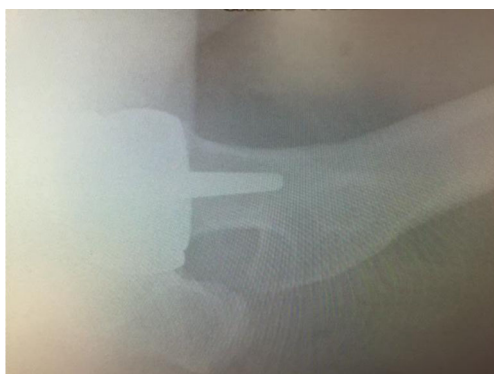
Fig. 2 Post-operative lateral plain film radiograph of the patient's left hip. No cause of the patient's mechanical symptoms was detected

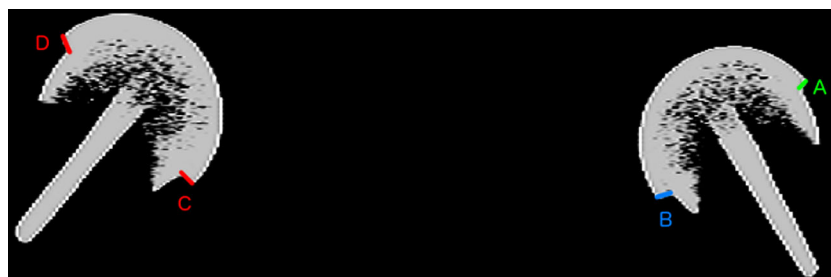
Fig. 3 A 2D CT coronal slice of the patient with the mismatched left hip resurfacing (*right*) and the patient's previous right hip resurfacing (*left*) in view. The femoral head of the mismatched component is not sitting

The same principle can be applied to 2D CT slices (Fig. 3), by comparing the distance between the outer surface of the acetabulum and the femoral head (AC–FH). Owing to metal artefact this was only possible at the edge of the acetabulum. For this reason, patients with mismatches due to oversized heads may go undetected because at the acetabular edge oversized femoral heads are centrally located and the AC–FH distance is equal (Fig. 7). We therefore recommend that 3D models are still generated to accurately visualise the difference between the femoral and acetabular centre of rotations in all planes.

centrally in the acetabular component with *B* being 1.5 times greater than *A*. On the previous right hip resurfacing, with correctly paired components, the femoral head is centrally placed (*C* to *D*)

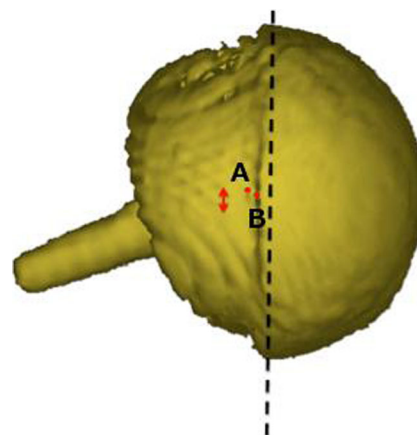
Three-dimensional analyses of the CT scan indicated a potential CSM (Figs. 4, 5). Results suggested that the acetabular-bearing diameter was 50 mm, highly suggestive of a 2-mm CSM, with the acetabular bearing surface 2 mm greater than the femoral head. Revision was recommended on this basis.

Fig. 4 Three-dimensional model of the patient's metal-on-metal (MoM) resurfacing. The acetabular (*A*) and femoral head (*B*) centres of rotation have been marked and the *red arrow* demonstrates that the two points are not overlapping, which indicated component size mismatch (CSM)

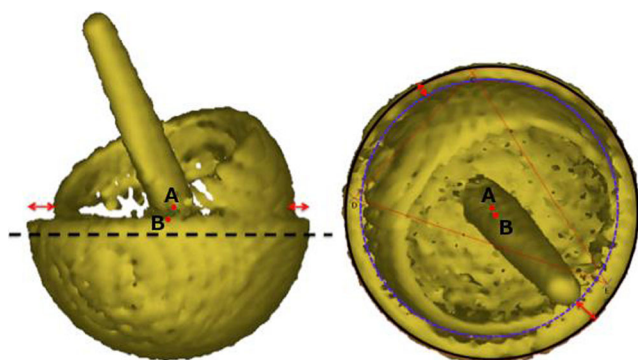
Fig. 5 Lateral (*left*) and true anterior–posterior of the acetabular cup (*right*) views of a three-dimensional model of the patient's MoM resurfacing. A is the acetabular centre of rotation and B is the femoral head centre of rotation. The *red arrows* indicate that the femoral head is not centred in the acetabulum, which suggests CSM

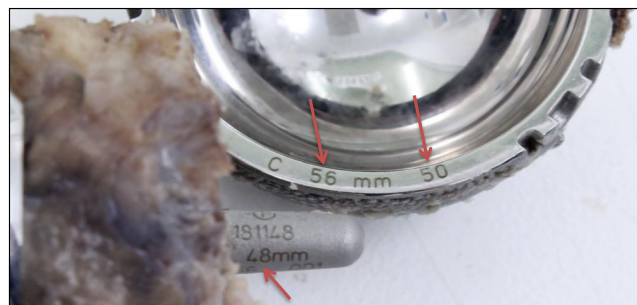
Fig. 6 Photo of the revised Adept hip resurfacing removed from the 53-year-old gentleman. Manufacturer labels in the surgical notes record the components as being a 56-mm cup designed for a 48-mm head and a 48-mm head. Engravings (*red arrows*) and coordinate measuring machine measurements confirm the CSM, as the cup is actually a 56-mm cup designed for a 50-mm head

To reduce the incidence of CSM, we recommend that component sizes are documented on the whiteboard in theatre (in the same way the swab count check is performed). In addition, this case highlights the importance of attempting to check the engravings on the acetabular component after insertion and not just relying on the boxes/stickers. However, this is not

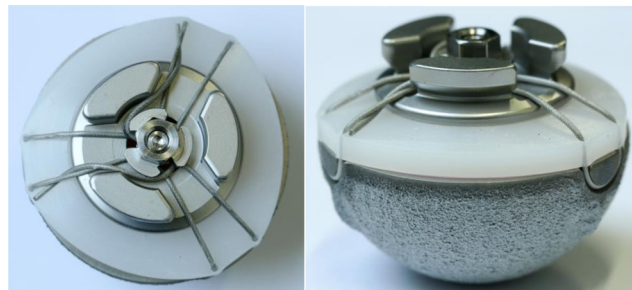
they are not visible before implantation as they are packaged with an impactor cap attached (Fig. 8).

Fig. 8 Photo of an acetabular component with the impactor cap still attached. The impactor cap covers the engravings and is removed only after insertion

Future work will incorporate the lessons learned from this case and retrieval data on mismatches to develop a modified WHO checklist with the aim of reducing the incidence of CSM. Within the modified WHO checklist it would be imperative for the engravings on the components to be directly visualised, either post-implantation or, if this proves too difficult to implement, pre-implantation, following a redesign of the impactor caps.
